Manhole Inspection Summary

Manhole # S29M__016MH

Insp Date: **12/4/08 10:23 AM**

Location Address: **815 W.Hamburg St.**

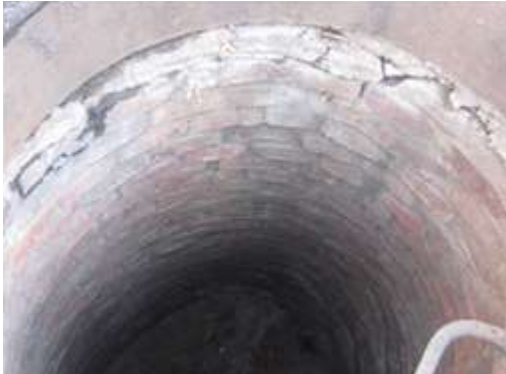
Defect 2

Infiltration: ☐ None ☒ **Joint** ☐ Cracks ☒ **Mortar** ☐ Roots ☐ Wall

missing mortar ar chimney with infiltration

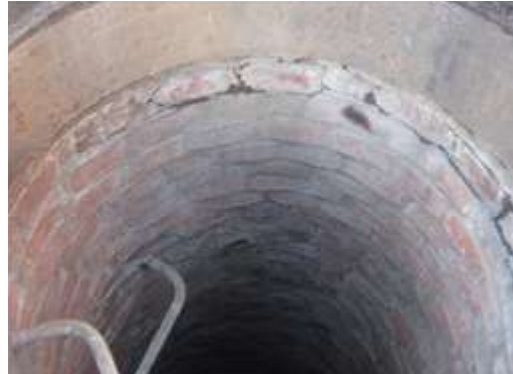
Defect 1

Condition: ☐ Sound ☐ Cracked ☐ Root Intrusion ☒ **Loose Brick** ☐ Deteriorated

chimney, loose bricks, joint infiltration

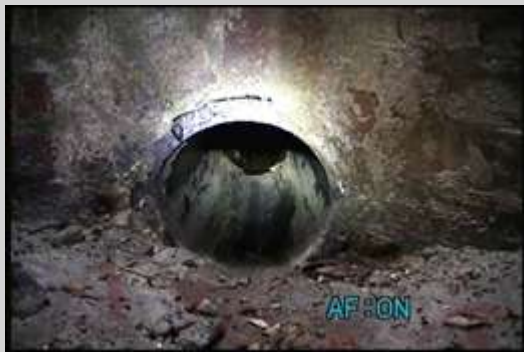
12 O'Clock Outflow

8 in. Circular Gravity Sewer
Pipe Out @ 12 O'Clock

Infiltration: **None** Pipe Seal Cond: **Sound**
